Engineering Report

Rochester ER STP 0162(19)

*Culvert No. 13 – VT 73 over Brandon Brook
Culvert Improvement Project – Rochester, VT*

Prepared for: Vermont Agency of Transportation
Prepared by: Vanasse Hangen Brustlin, Inc.
Date: June 1, 2012

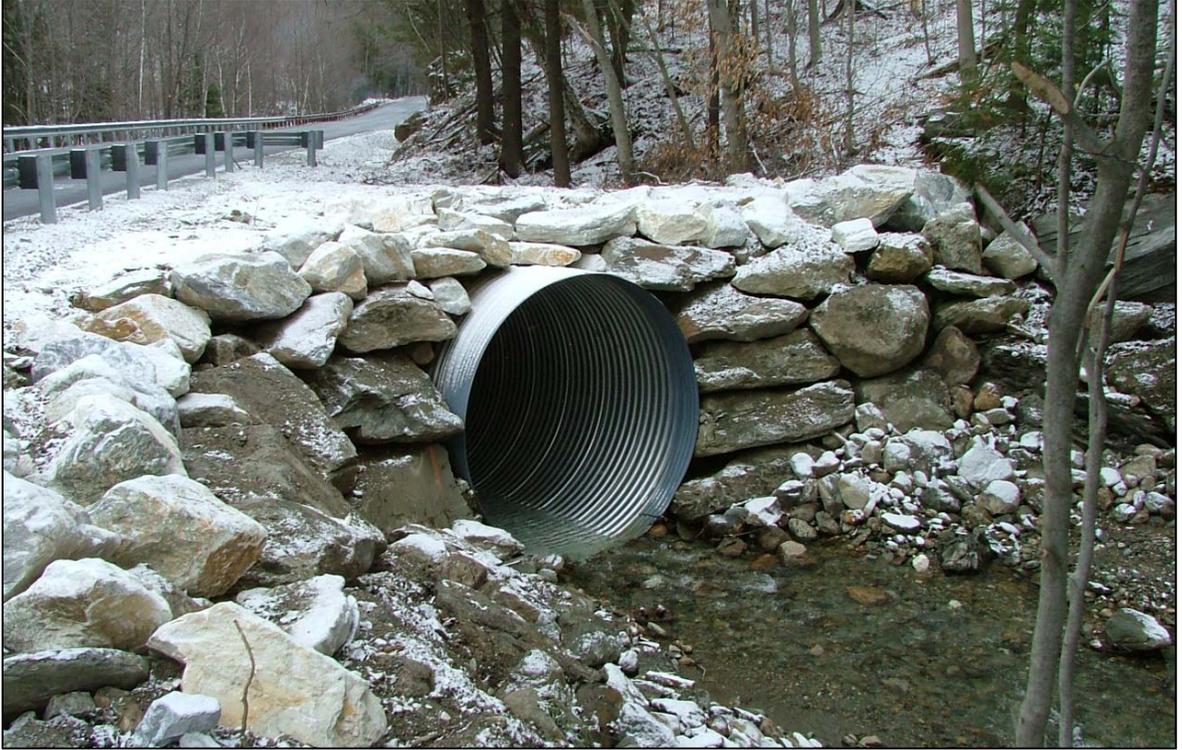
Inlet of Temporary Culvert

The temporary culvert is in good condition with a dry laid stone headwall at its inlet. Stone rip rap is located to the west of the dry laid stone along the south side of VT 73 prior to the culvert. Stone riprap has been placed on both sides of the outlet to repair the erosion caused by Tropical Storm Irene. There is a stone lined ditch along the northwest side of VT 73 which drains into Brandon Brook at the culvert outlet. Beyond the culvert the north side slopes of VT 73 extend down to Brandon Brook at a 1.5H:1V slope and are stabilized with stone fill. The south side of VT 73 is forested and extends upward with visible ledge outcroppings along the south side of VT 73. There are no overhead utility lines along VT 73 within the project area.

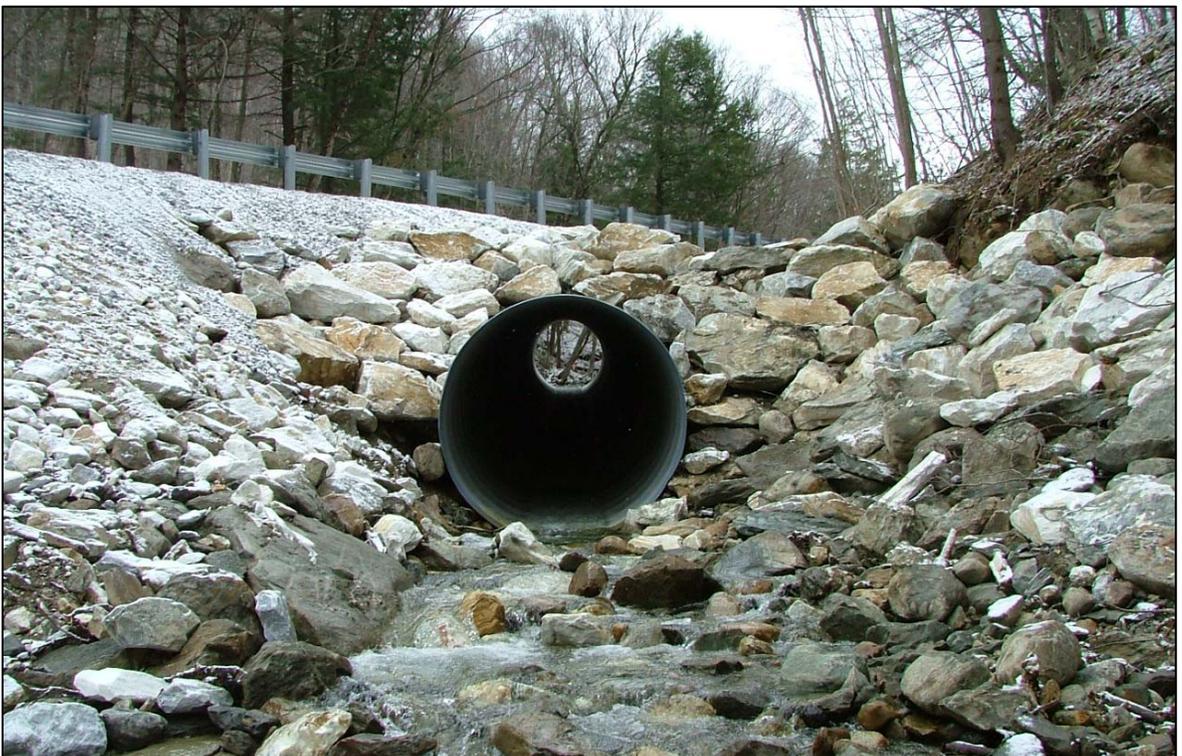
Outlet of Temporary Culvert

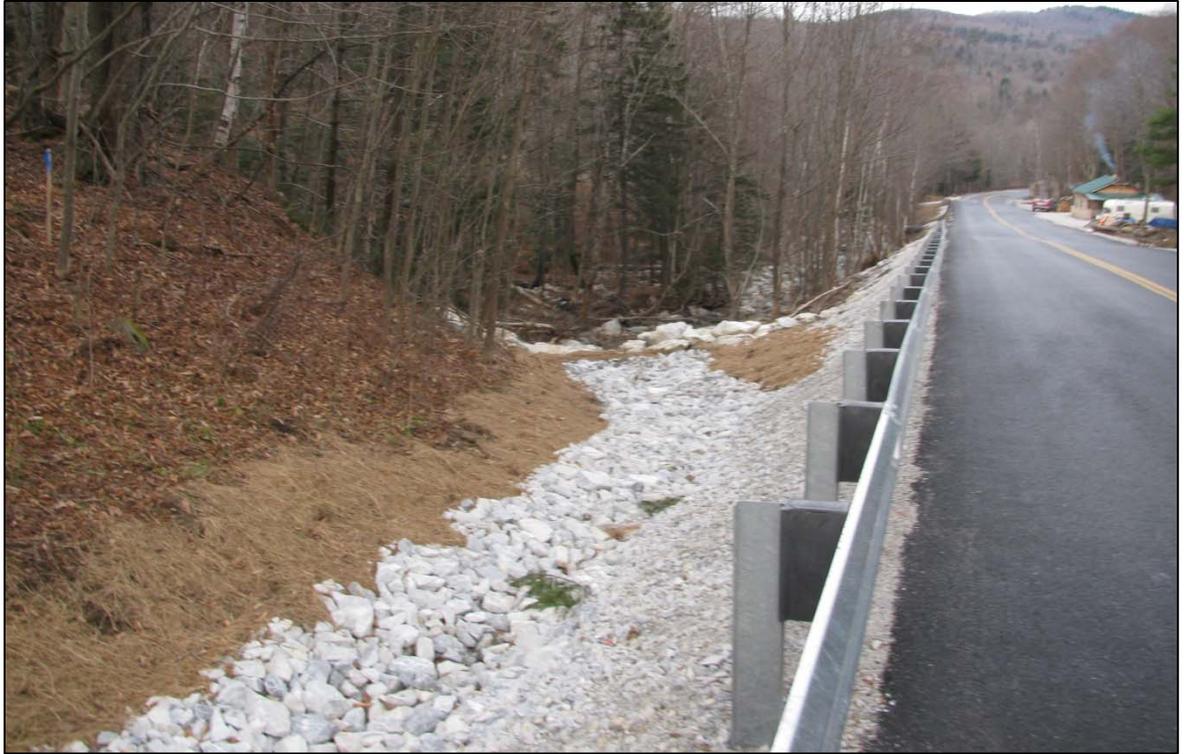
Stone Lined Ditch on Northwest side of Temporary Culvert

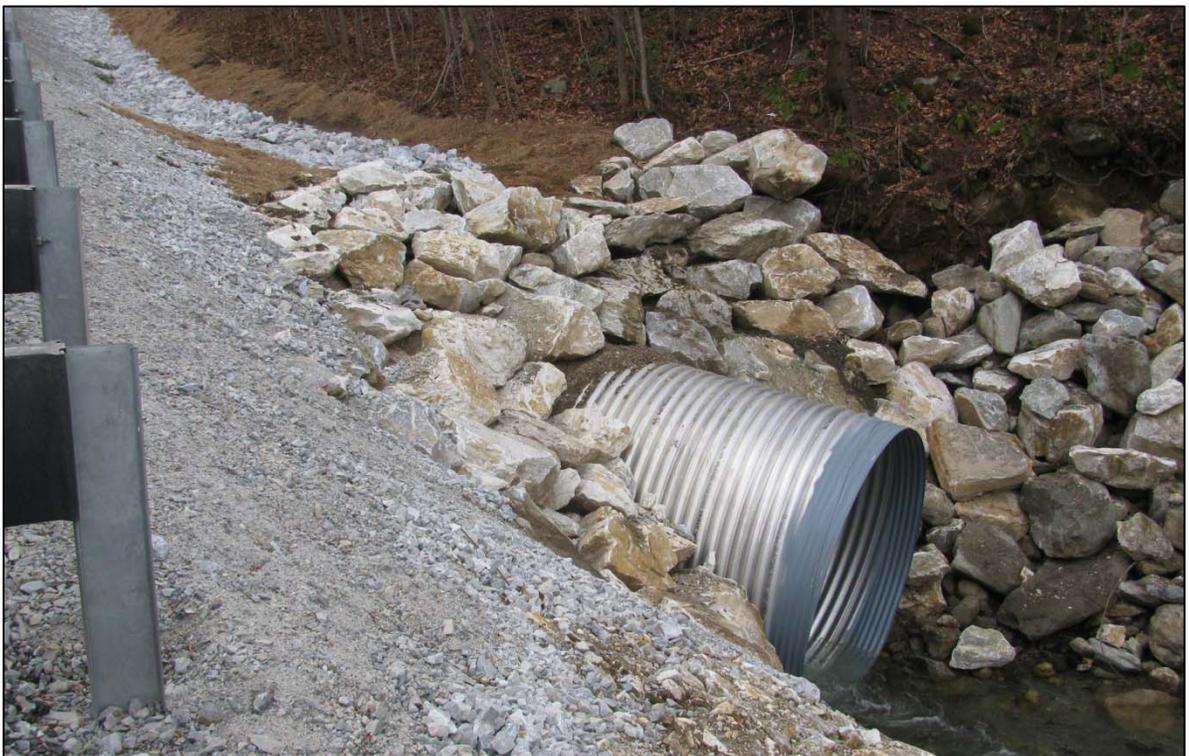
Outlet of Stone Lined Ditch and Riprap Side Slope at Temporary Culvert Outlet

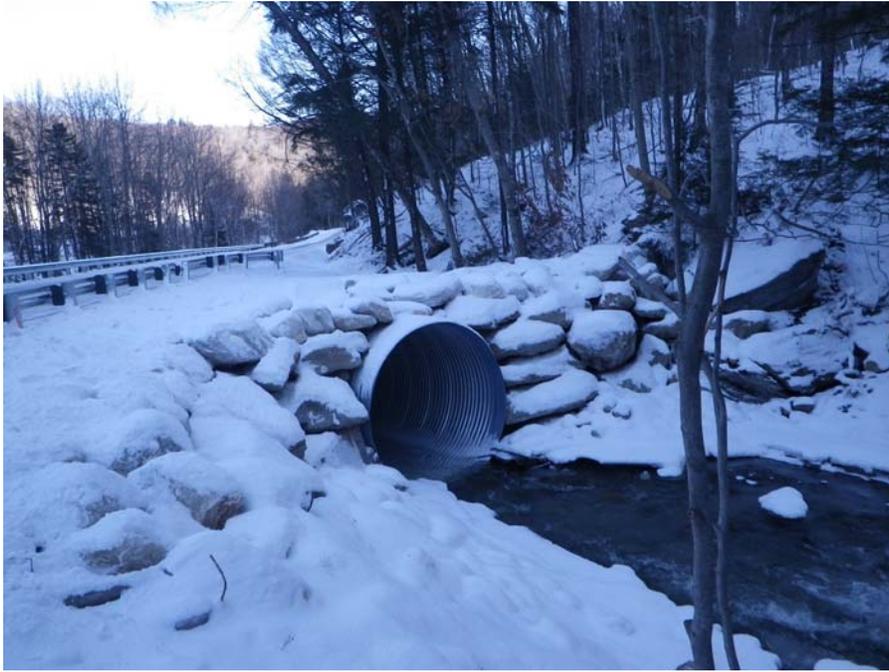
Photo 1: View looking at upstream invert of Bridge No. 13 temporary culvert on Brandon Brook. Photograph taken by VHB on 12/29/11
