Engineering Report

Rochester BRF 0162(16)

*Bridge No. 15 – VT 73 over Brandon Brook
Bridge Improvement Project – Rochester, VT*

Prepared for: Vermont Agency of Transportation
Prepared by: Vanasse Hangen Brustlin, Inc.
Date: July 13, 2012

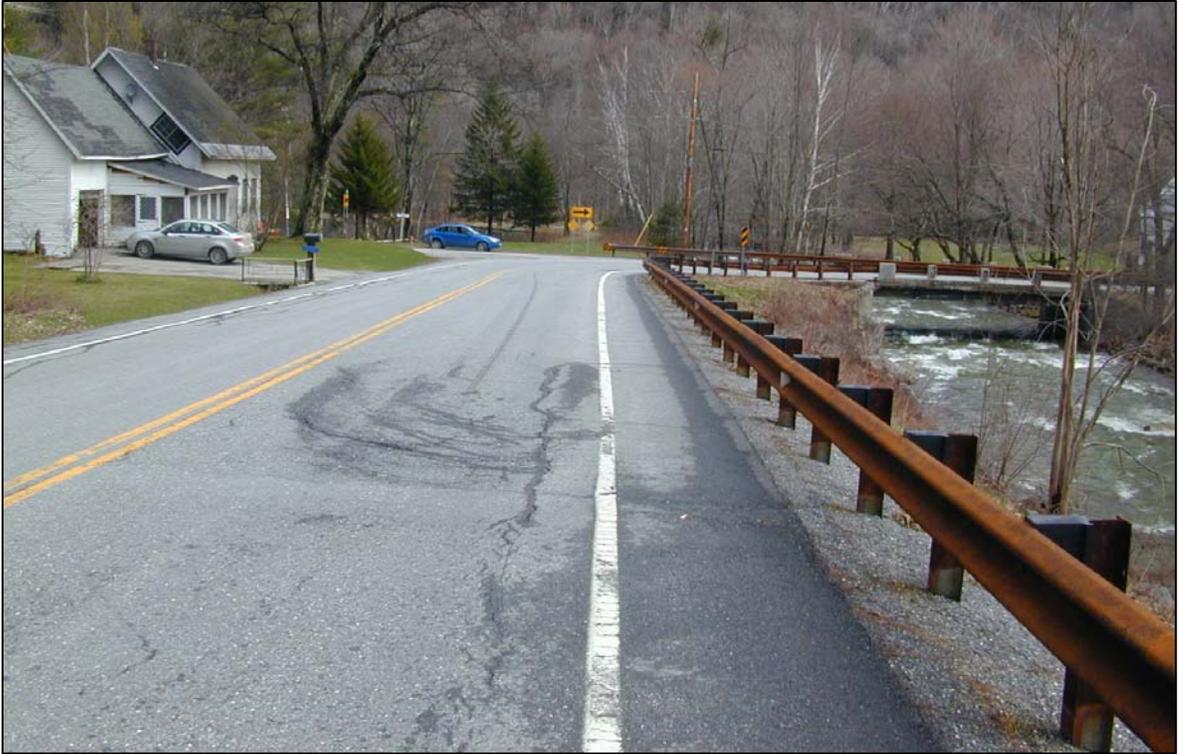
Looking East on VT 73

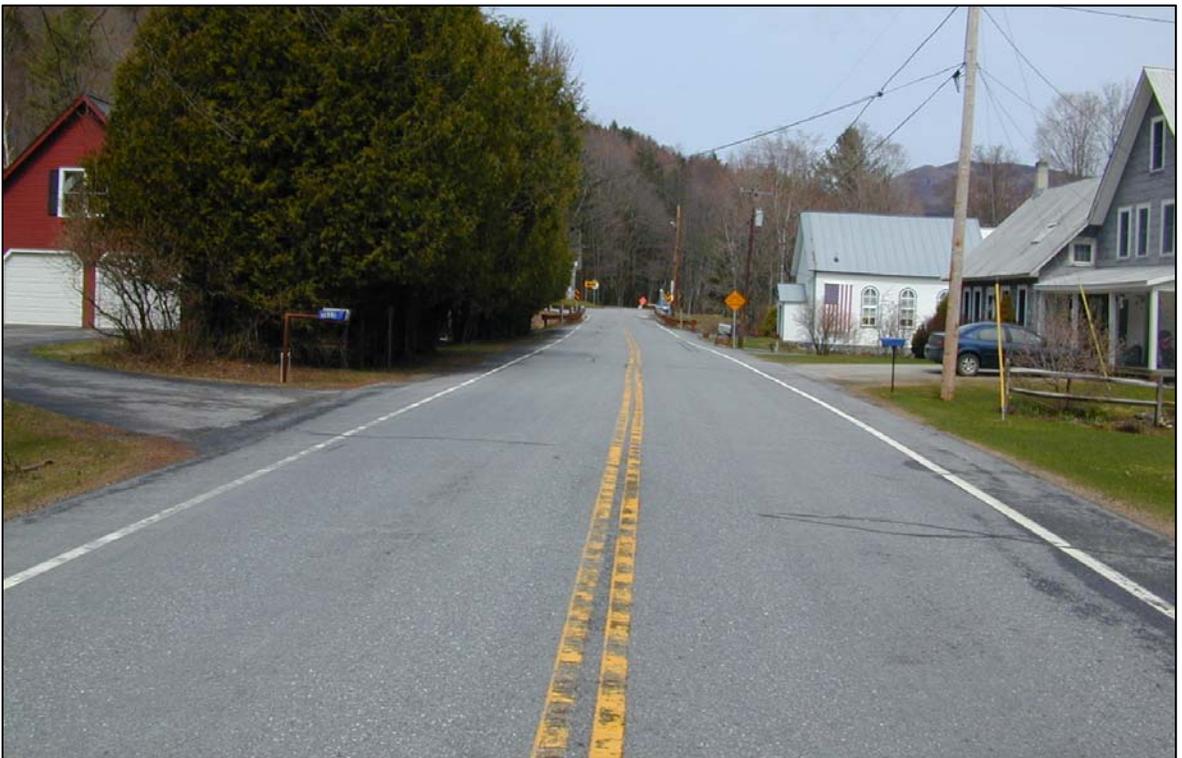
Looking West on VT 73

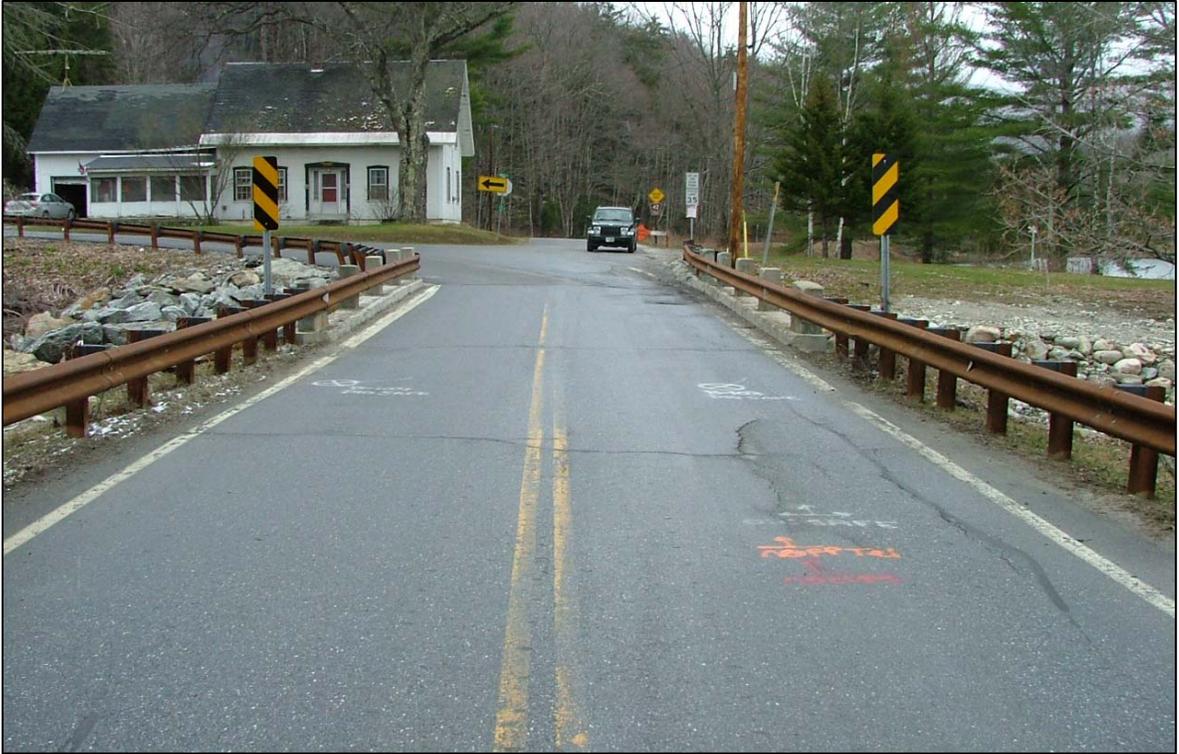
Sharp Corner and Bingo Road on West Side of the Bridge

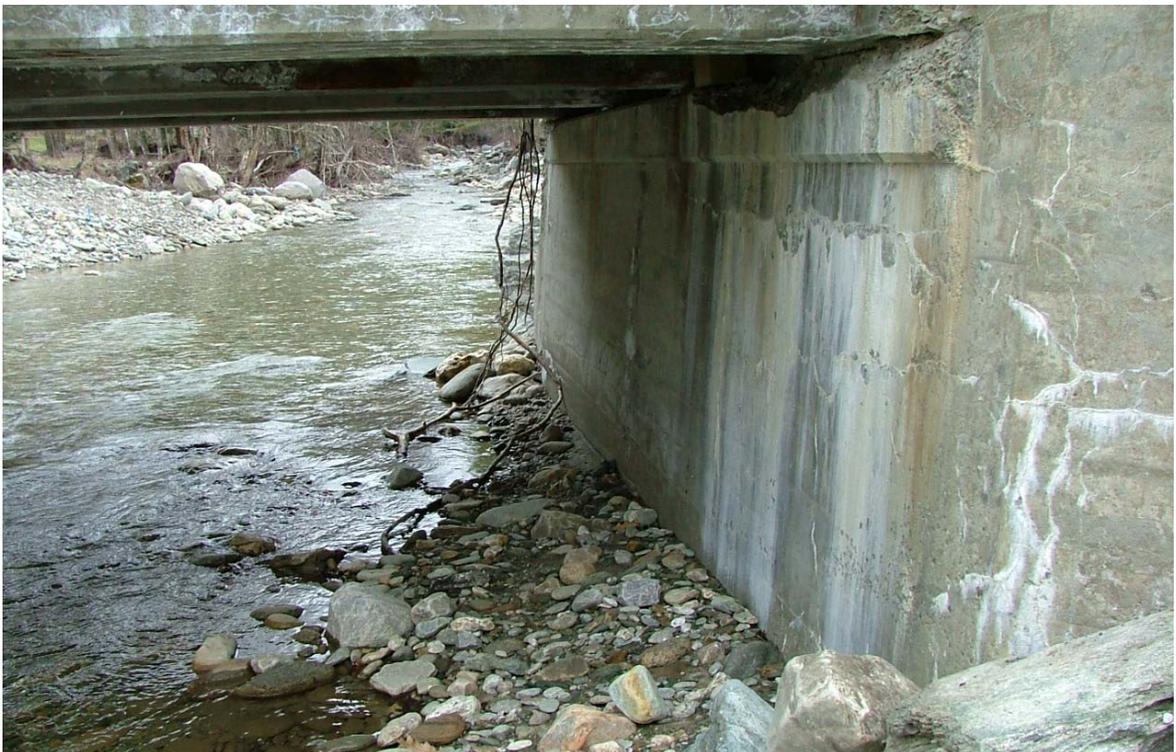
West Abutment

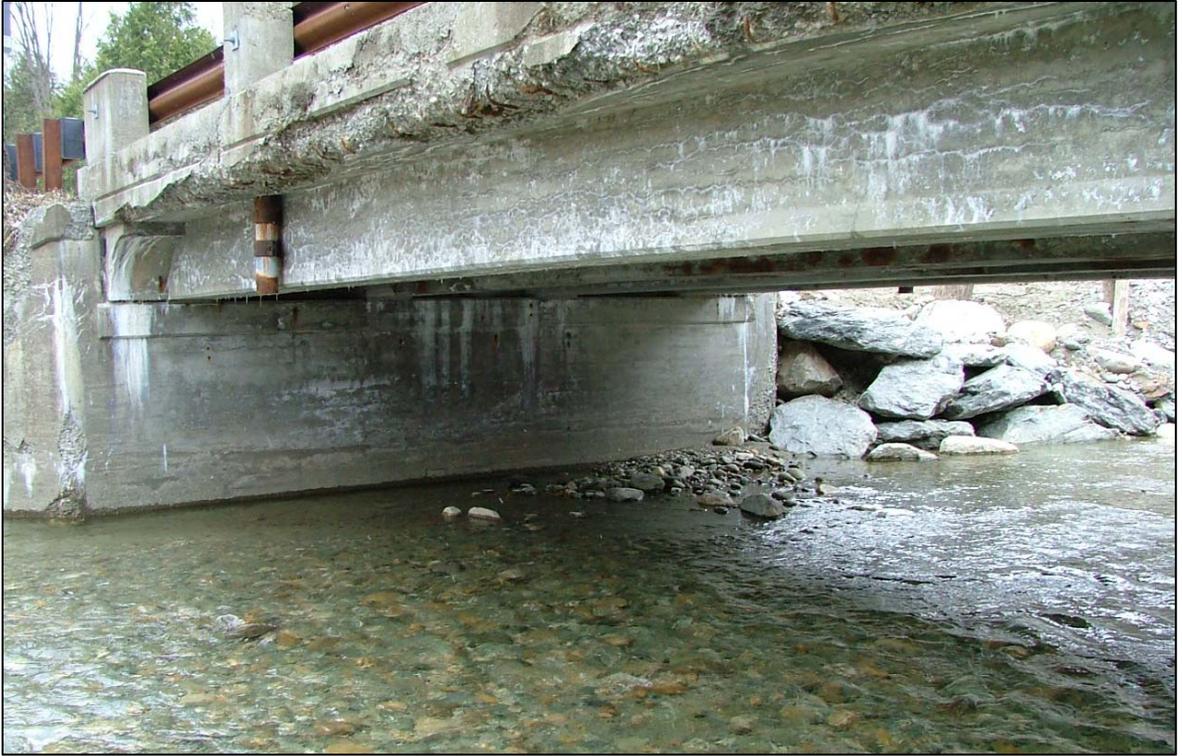
East Abutment

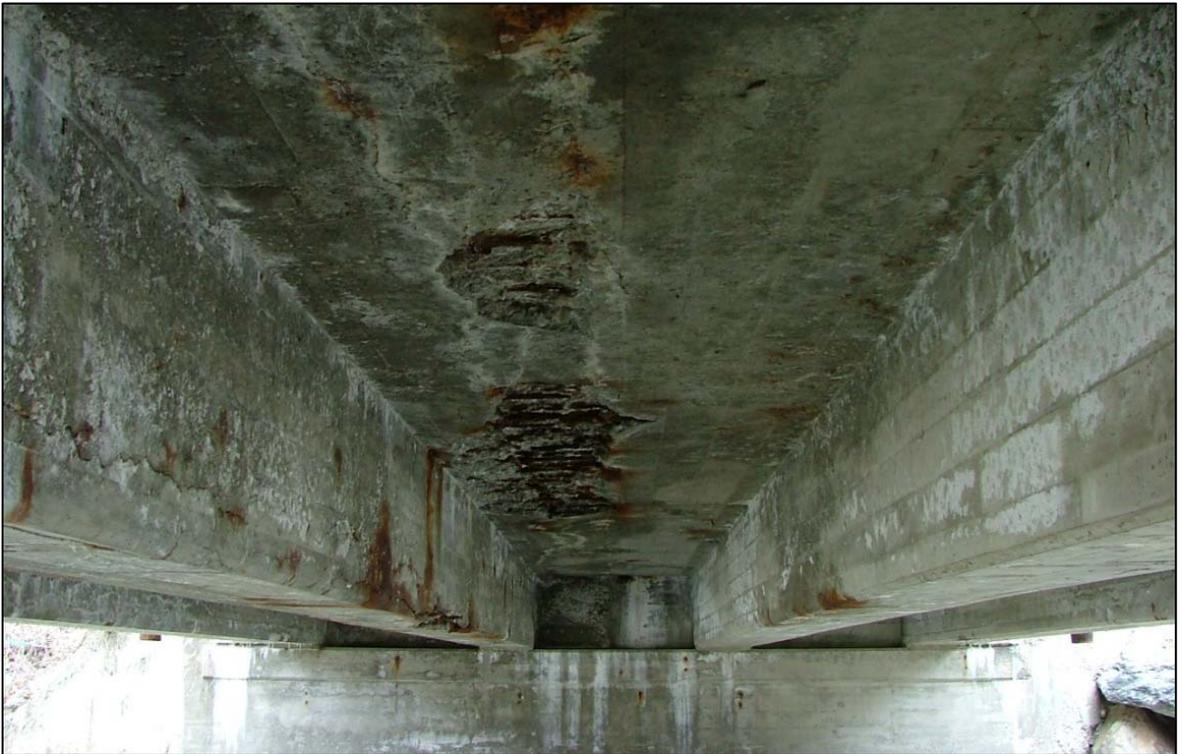
Concrete T-Beams and Underside of Deck

The existing superstructure components are noted as being in poor condition with wide-spread areas of map cracking, efflorescence and spalling prevalent on the fascias and underside of the concrete T-beams. Rusted reinforcing is also visible on the bottom of the downstream interior concrete T-beam and rust staining is present along the webs of all of the T-beams. The deck is in poor condition with previous concrete repairs noticeable in the first downstream bay and large areas of spall with exposed reinforcing present in the middle bay. The concrete deterioration; map cracking, efflorescence, and spalling, is also noticeable on the exposed areas of the abutments. The latest bridge inspection report states that the deck geometry is "intolerable, replacement needed" due to the narrow bridge, and on 06/20/2011 it was noted that the "The deck is in need of full replacement...Full depth holes may occur at anytime anywhere before next inspection." The bridge rail does not meet the current design standards as noted in the VTrans Inspection Report (Appendix B). There are overhead utility lines within the project area.

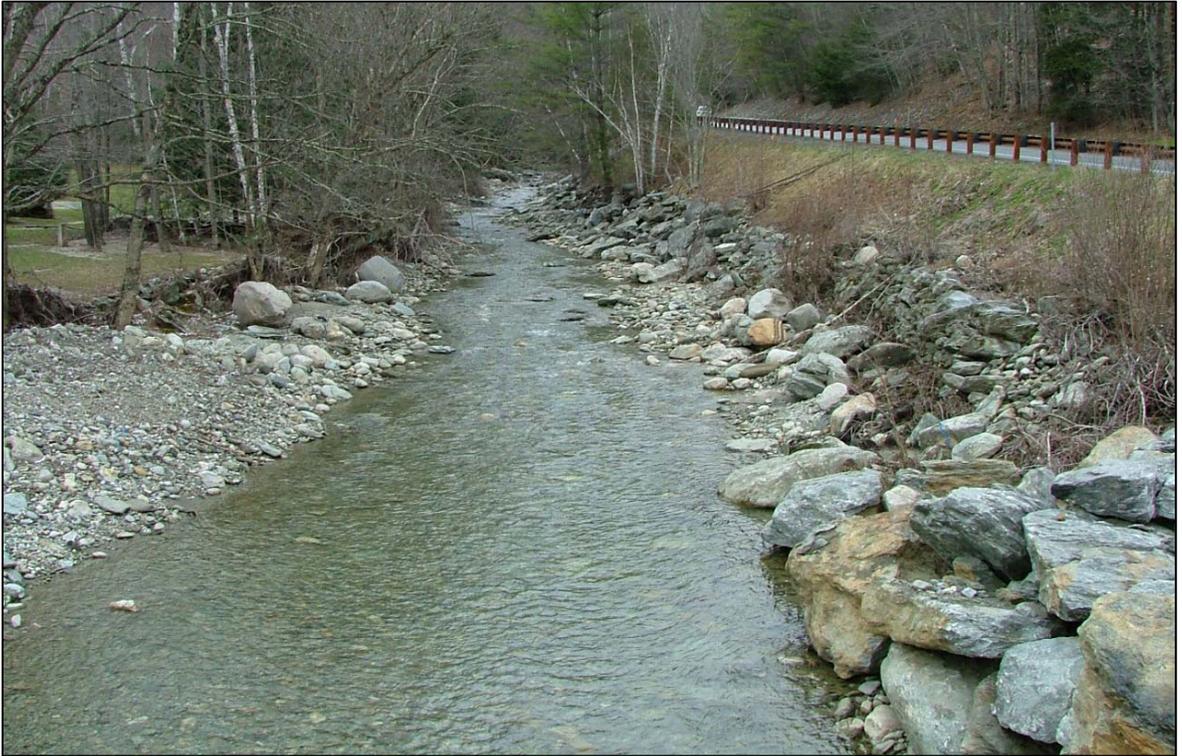
Looking Upstream

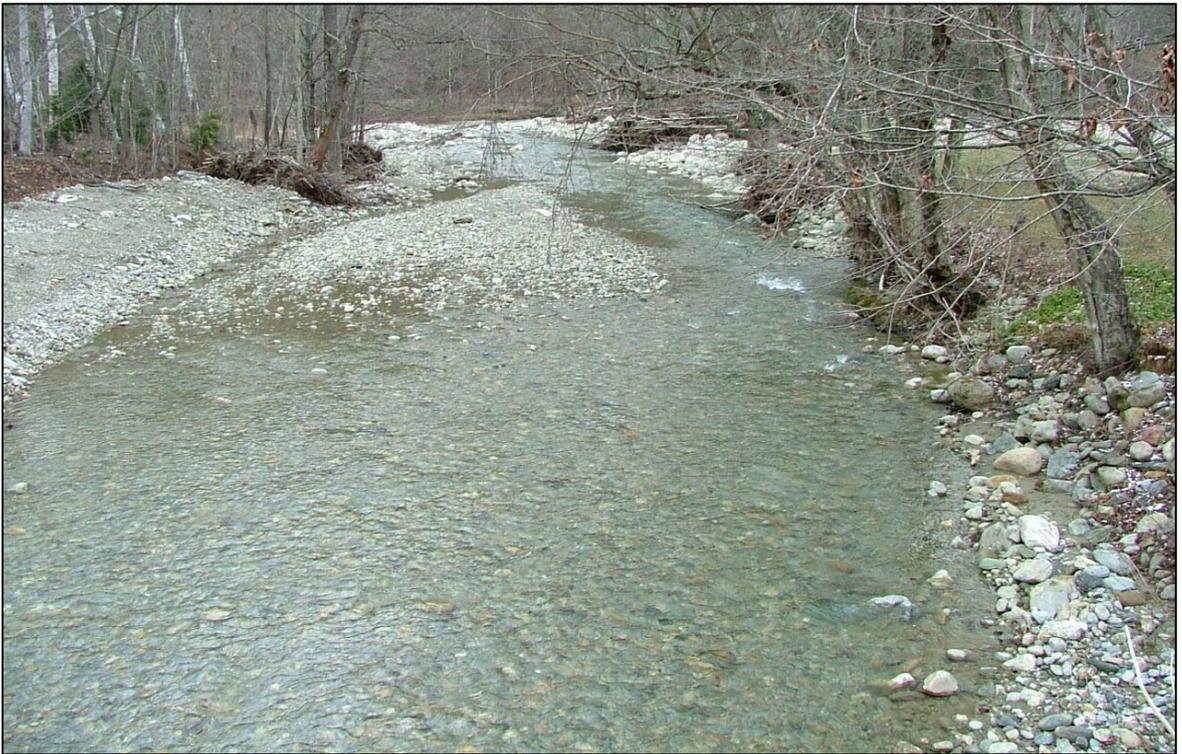
Looking Downstream

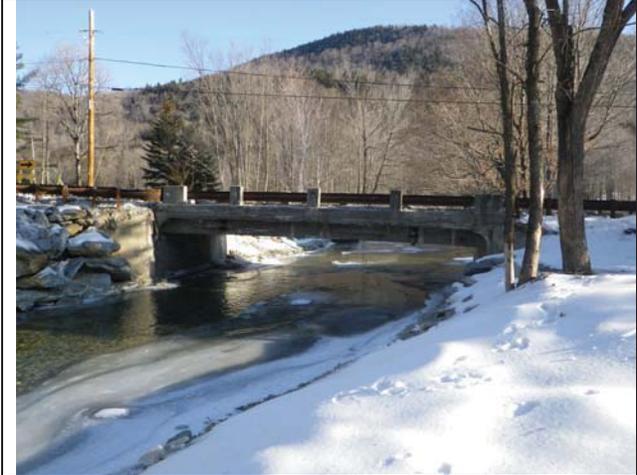
Photograph 1. Looking downstream along Brandon Brook at Bridge 15

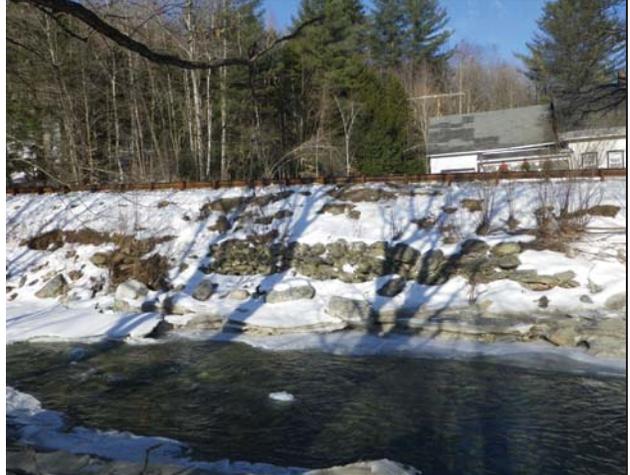
Photograph 2. View of left bank descending and Route 73 ROW embankment

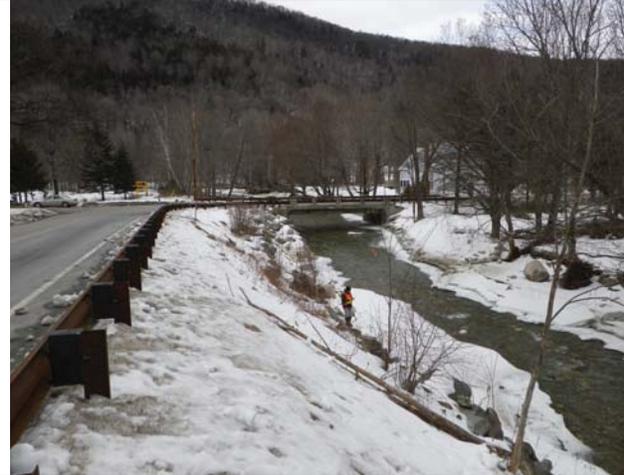
Photograph 3. View of VT 73 ROW looking downstream and Bridge 15 over Brandon Brook

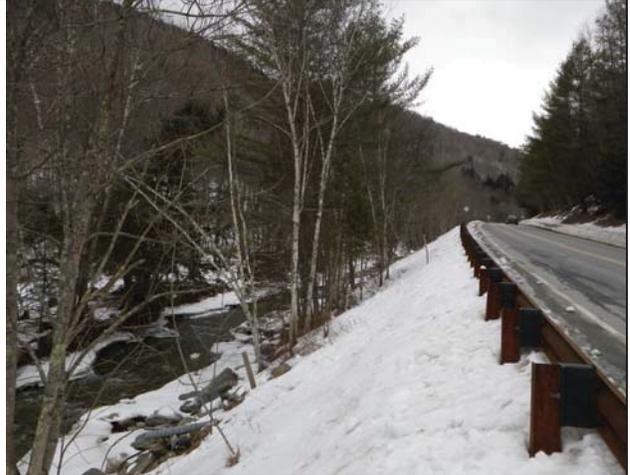
Photograph 4. Looking upstream Brandon Brook along Route 73

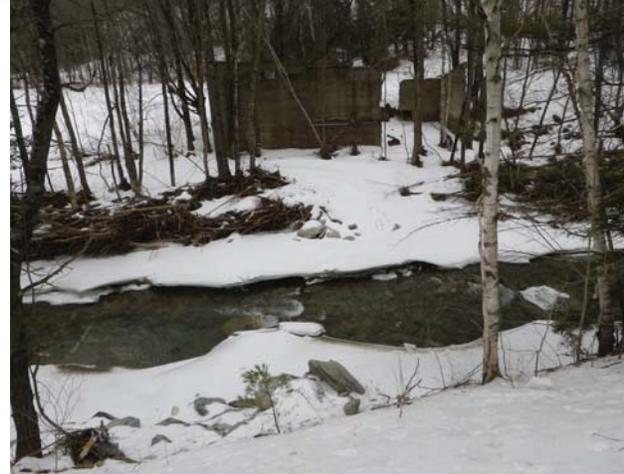
Photograph 5. View of Right bank descending and adjacent structure

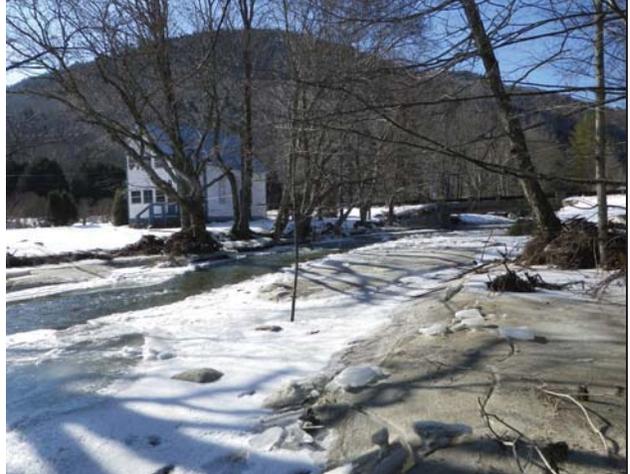
Photograph 6. View of adjacent house and Brandon Brook looking upstream towards Bridge 15
